Manhole Inspection Summary

Manhole # S17OO1005MH

Insp Date: **12/15/06 9:30 AM**

Location Address: **4810 TAMARIND RD**

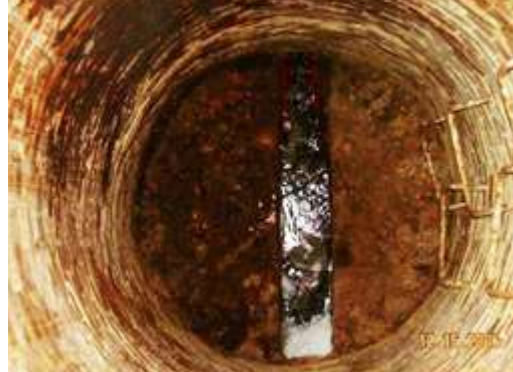
Top View

Infiltration: ☐ None ☐ Joint ☐ Cracks ☒ **Mortar** ☐ Roots ☒ **Wall**

Condition: ☐ Sound ☐ Cracked ☐ Root Intrusion ☐ Deteriorated ☐ Leaks ☒ **Debris**

Steps Count: **10** Missing: **0** ☒ **Corroded**

Surcharge ☒ **Evidence Of Surcharge** Depth: **2** (ft.) ☐ Active Surcharge Present

Corroded steps. Barrel infiltration.
Evidence of surcharge - Bench debris.
Channel debris.

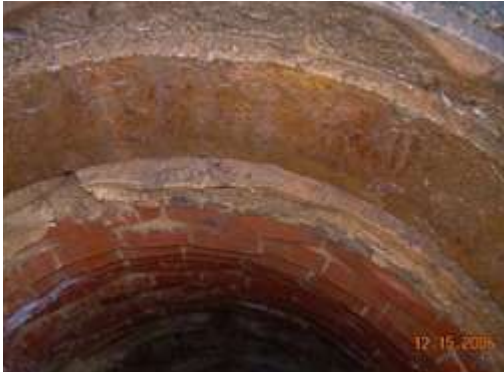
Defect

Frame Offset: **1** (in.) Condition: ☐ Sound ☐ Cracked ☒ **Leaks**

Condition: ☐ Sound ☐ Cracked ☐ Root Intrusion ☐ Loose Brick ☒ **Deteriorated**

Infiltration: ☐ None ☒ **Joint** ☐ Cracks ☒ **Mortar** ☐ Roots ☐ Wall

Frame leaks. Adjustment deterioration
and infiltration. Barrel infiltration.

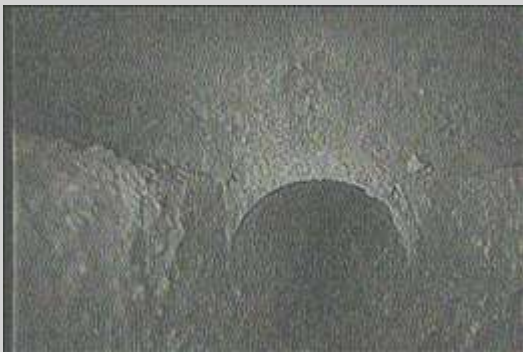
8 in. Circular Gravity Sewer Pipe Out @ 12 O'Clock

Deposits: ☐ None ☒ **Mud** ☐ Sludge ☒ **Debris** ☐ Grease

Silt Depth: **0.5** (in.) Deposits Extent: **Light**

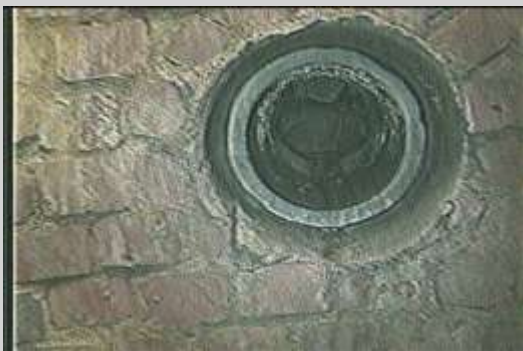
8 in. Circular Gravity Sewer Pipe In @ 6 O'Clock

Deposits: ☐ None ☒ **Mud** ☐ Sludge ☒ **Debris** ☐ Grease

Silt Depth: **1** (in.) Deposits Extent: **Light**

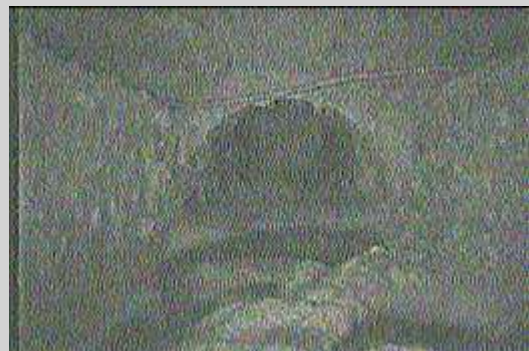
Drop In @ 6 O'Clock

Drop: **Outside** **Direct**

Drop Condition: **Open**
